Product Update

SER 25-004 Rev B

Premature Gear Wear on P2514/P2314 Hoists

July 18, 2025

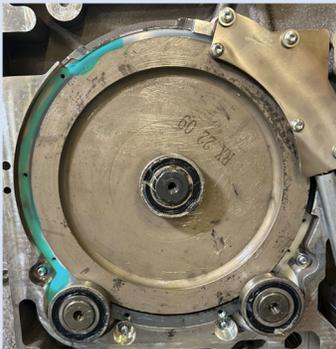
7	<p>Upon inspection of the ring gear (per service manual, remove wear blocks and lift highlighted seal to inspect), was any wear found?</p>
