703712/A

Spider®

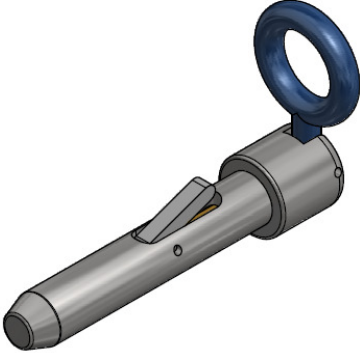
PURPOSE
It has been reported in the field that the Quick pin can fail in such a way as to become stuck in the Mod connection. The failure is the internal compression spring slips past locking lever causing the locking lever to jam in the locked position.

Spring slips off of locking lever 710029-1 |

If you have a PN: 710029-1Quick pin that has a failure and is covered within warranty, contact either Customer Service or Product Support for RMA to return quick pins to TOC and arrange replacement pin PN; 702181-1 Pin with Lanyard and Clip.

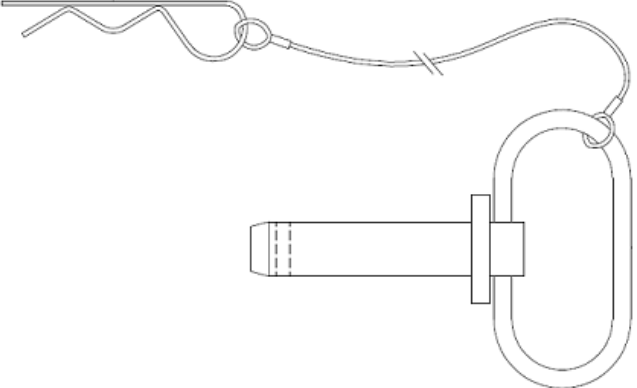
| A new pin pn 702181-1 with a lanyard and clip attached is available to replace pn 710029-1 quick pin.
