Case Study 19: Wind Turbine Access

Hackberry - Albany, TX

Turbine: Siemens 2.3MW

Access for blade inspection and repair work for Siemens 2.3 MW turbines

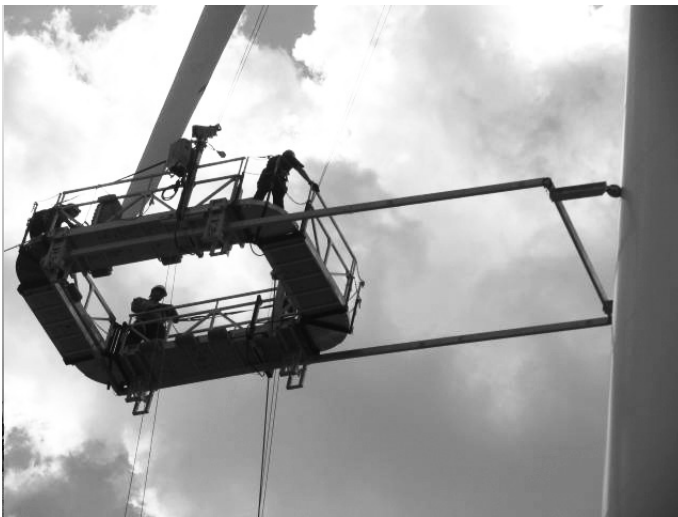
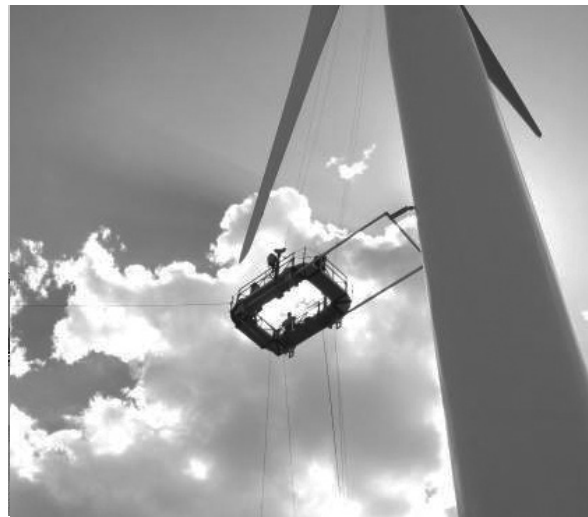
- Spider provided a 5 x 10 ft (1.5 x 3 m) configured 360 Blade Access Platform (BAP) with independent lifeline.
- With Spider's expertise in safety, rigging and training, Lankford Company was able to bring in the 360 BAP closer, could simply adjust to the larger blade tip with the manual winch, and could easily access the blade repair area.

- With the 360 BAP assembled on the ground, workers engaged the blade tip in less than 8 minutes to start the work.
- Storage buckets positioned the workers' tools at waist height for added productivity.

- With both a primary and secondary suspension wire rope to each hoist, the workers were able to attach their fall protection lanyards directly to the engineered PFAS safety anchor device on the walk-thru stirrup. This point is also engineered for use with a descent device, if users choose not to use the hoists' no-power controlled descent system.
